Re: CISC Technical Memorandum No. 5, 1985.02.22

Ultimate Compressive Capacity of a "K" Brace Connection Detail

CISC TECHNICAL MEMORANDUM NO. 5

Re: Ultimate Compressive Capacity of a 'K' Brace Connection Detail

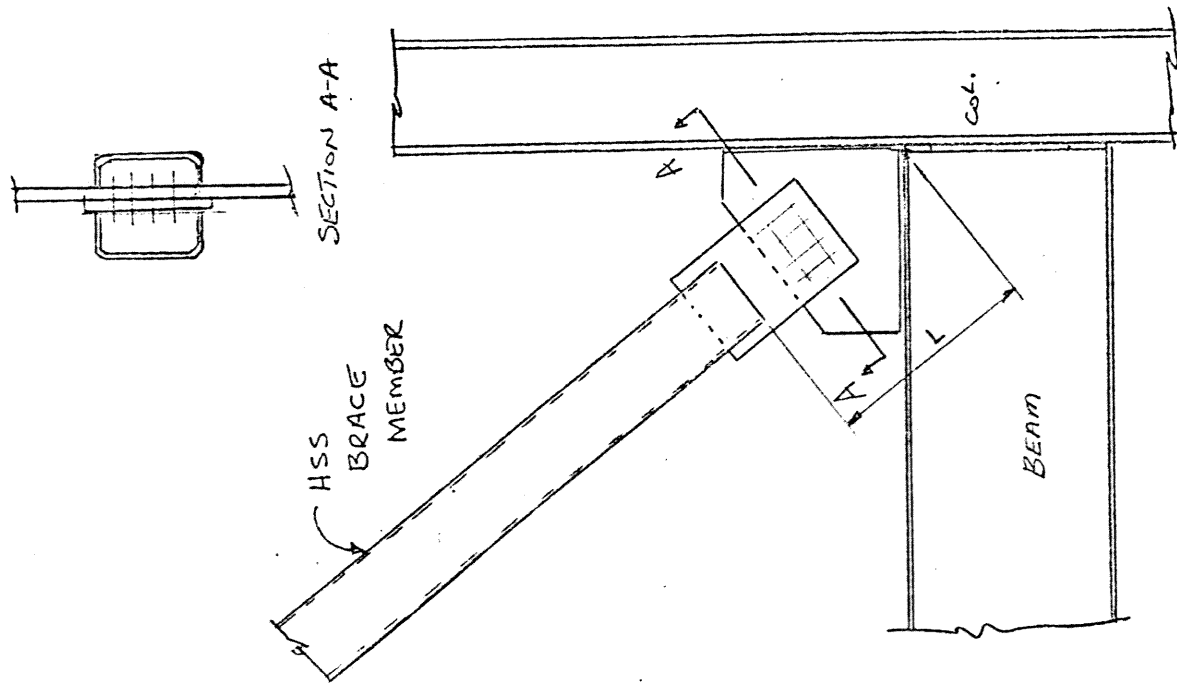
SKETCH 'A'

Sketch 'A' on the attached sheet shows part of a 'K' brace joint detail. The brace member is a large hollow structural section (HSS) and the connection consists of a flat plate welded into a slot in the HSS. The HSS and the connection plate are connected to the gusset plate at the beam-column joint with bolts in a simple lap splice.

Although this type of detail has been used successfully in 'X' bracing systems for tensile loads, its use in 'K' bracing under compressive loads had come under scrutiny. It has been reported that this detail has failed in compression in a structure in Canada. A detailed analysis, such as a finite element, together with an actual test of a full-size specimen have shown that using an effective length factor, K , of 1.2, a length, L , measured from the end of the tube to the point where the centre line meets the supporting beam or column flange, and designing the connection solely for axial load significantly overestimates the ultimate capacity of this detail. The actual failure load measured in the test was only 75% of the specified (working) load. Significant lateral deflection of the gusset plate at low loads was observed in the test due to the eccentric line of action of the forces.

Although specific design recommendations for the detail shown are not available at this time, the use of a stiffener is highly recommended.

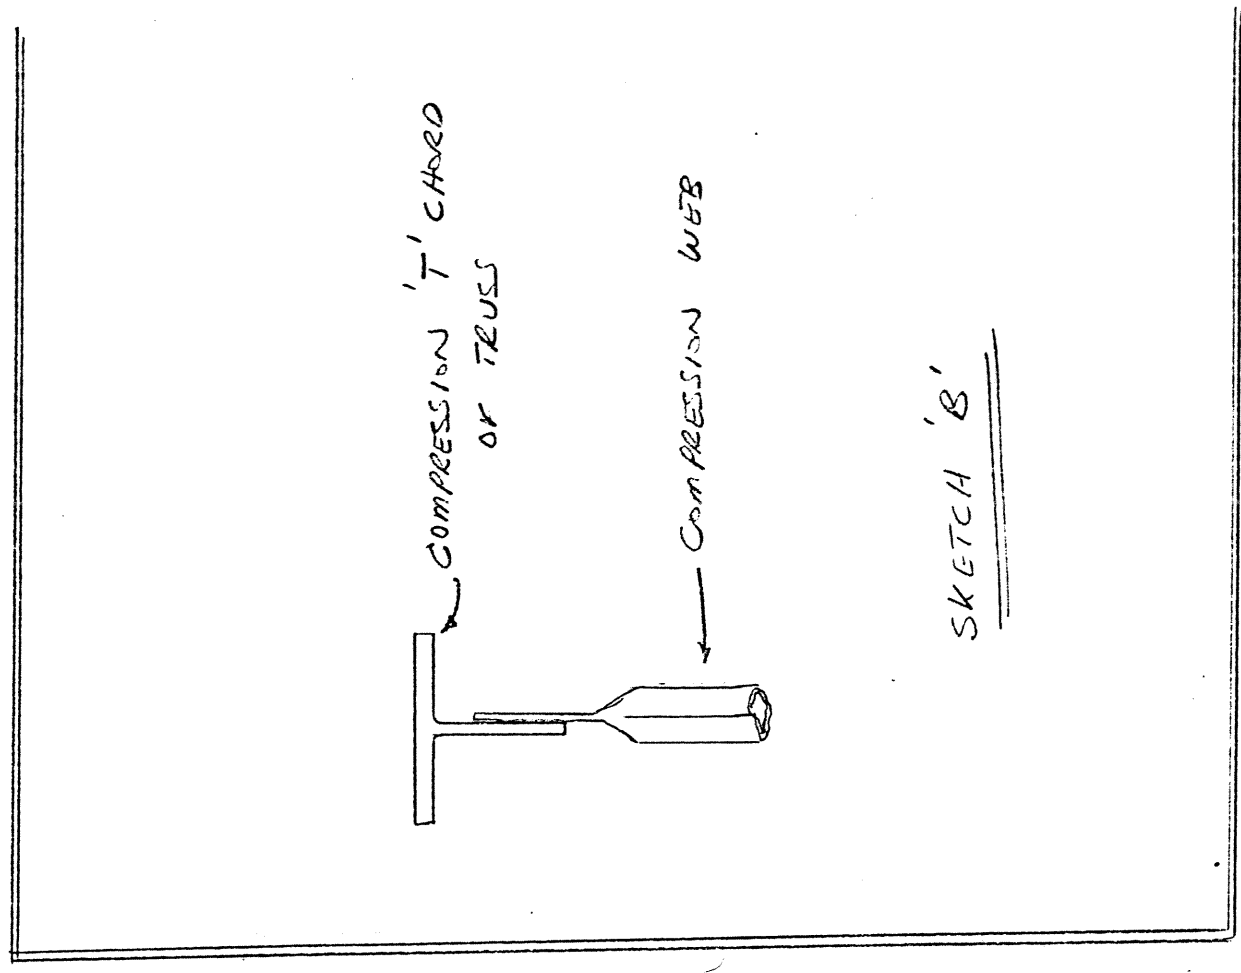
Sketch 'B' shows a somewhat similar detail of a connection of a crimped square HSS to the stem of a 'T' compression cord. A failure of such a truss, also in Canada, is recorded in the technical literature. Although the actual cause of failure is still to be determined, susceptibility to a similar mode of failure as described for the detail in Sketch 'A' can be envisaged.
